10th International Symposium on District Heating and Cooling

Leakage ways for ground-water in PUR-foam

S.-E. Sällberg, S. Nilsson, G. Bergström,
SP Swedish National Testing and Research Institute, Göteborg/Sweden

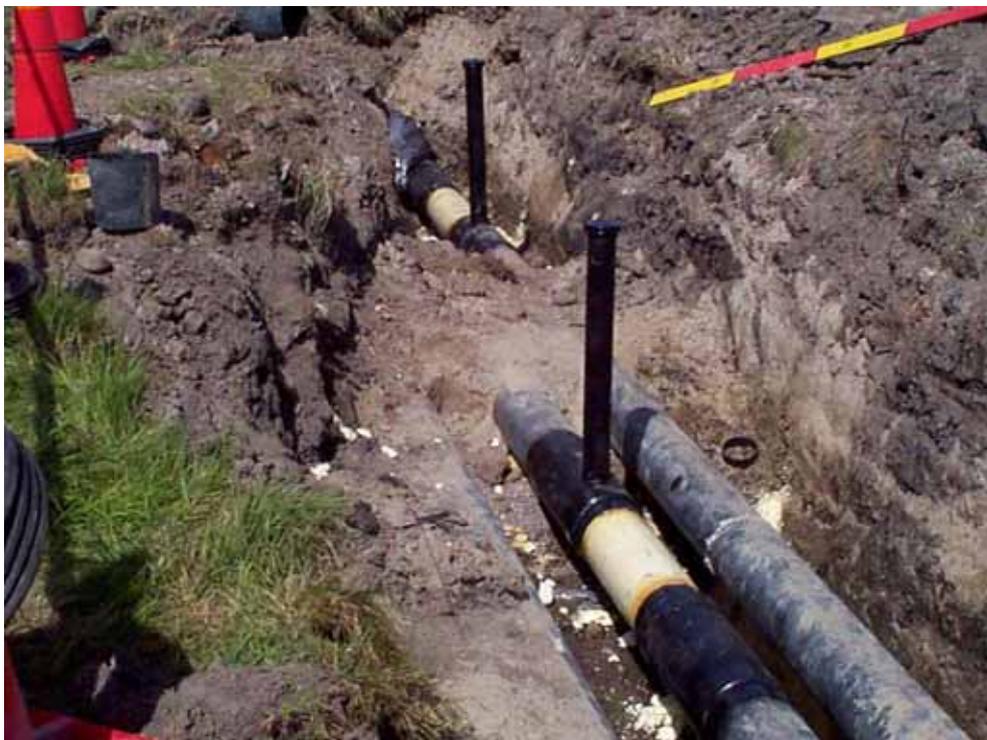
Figure 1. Installation of casing free pipes in Hisings-Backa, Sweden. North direction is towards the top of the photograph.

In order to examine to what extent PUR foam can be regarded as water tight when used in service, two pipes without casing, i.e., with naked PUR foam, was installed on a district heating pipeline, figure 1. The pipes, of dimension DN 150/280, were approximately one meter long. They were laid in wet surroundings where the ground water level occasionally reached above pipes. The pipes were used in service for approximately four years at a continuous operating temperature of about 80 °C.

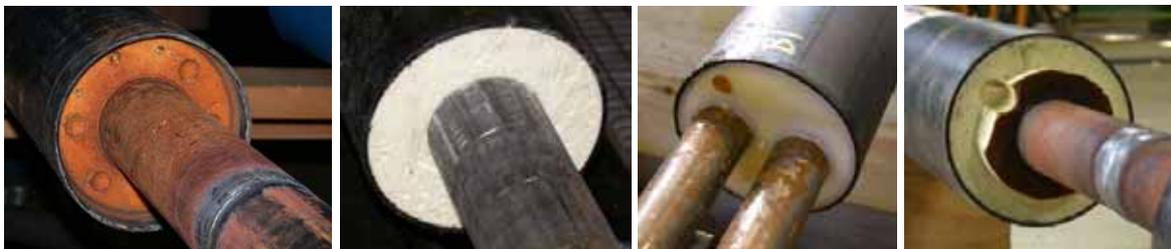
Figure 3. Examples of pre-treatments of pipe ends: A) Normally stored. B) Clean cut. C) Polyethylene end seal. D) Staircase surface profile.

1. *Pipe diameter* – the flow pattern of the PUR components is different in large and small pipes and it may be more difficult to obtain a complete foam filling in a large pipe.
2. *Single/twin service pipes* – for the same reason as above, a complete foam filling may be harder to obtain with two service pipes in one casing.
3. *The pre-treatment of the pipe ends* may affect the adhesion of the joint foam. Three variants were tested: normally stored and weathered, clean cut and with a polyethylene end seal applied, cf. figure 3A, B and C respectively.

4. *The surface profile of the pipe end.* It was hypothesised that a “staircase” shape may yield a better adhesion to the joint foam, cf. figure 3D.
5. *The temperature during foaming* is known to influence the foam properties. Three alternatives were tested: room temperature, 0 °C in ambient air and on joint space surfaces and +80 °C on service pipe with room temperature in ambient air.
6. *The foam density* was varied between “normal” and “high”.
7. *The foaming method.* Two variants were used: machine injected foam and hand-mixed bottled foam.

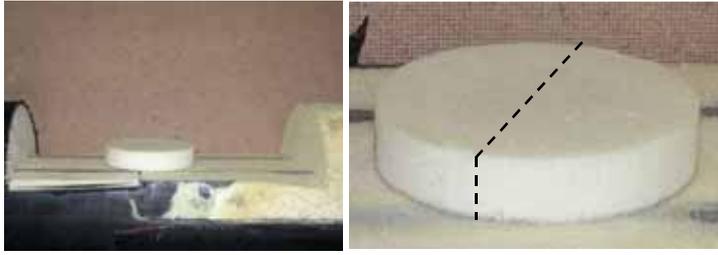
Figure 4. Test specimen for water permeability measurements. The dashed line indicate the foam interface. Hence, there is pipe foam to the left of the line and joint foam to the right.

For the water permeability measurements, disc-shaped test specimens were sawed out from the foam covering the interface, figure 4. Reference samples were also taken, containing only joint foam and pipe foam respectively.. All test specimens were 20 mm thick with a diameter of 81 mm.

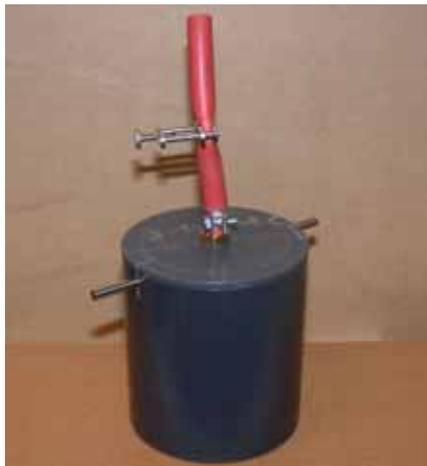
Figure 5. Test rig for water permeability measurements. H is the cylinder's total height, T is the thickness of the lid inside the cylinder, L is pressurised air volume, V is the water depth when the test starts, P is the PUR samples thickness and B is the height of the volume open to the ambient air.

Each test specimen was then fixed in a plastic cylinder with inside diameter 81 mm, figure 5. At its top end, the cylinder was tightened by a lid with a pressure inlet.

Before starting the measurements, each test rig was filled with a known quantity of water and its weight was determined. The test rigs were then pressurised through the rubber tube to 0.05 bar above atmospheric pressure to obtain a water pressure equal to that from a ground water level 500 mm above a leaking joint in service.

By weighing the test rig, the amount of water escaping through the foam can then be determined. Even a water tight foam will lose weight from diffusion of vapour, but if permeation of liquid water takes place, the water loss will be significantly faster.

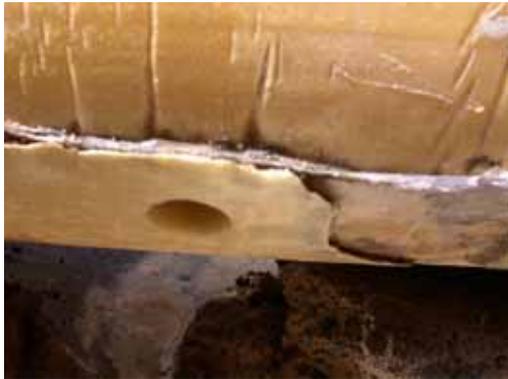
Figure 8. Crumpled polyethylene foil. Defect in the PUR foam from the production process.

age is limited to a small region. This can be explained by the fact that no casing is present to trap the moisture. When water enters the foam through the defect in figure 8, it will vaporise and diffuse quite rapidly to condense near the cold surface.
